# Back analysis of a coastal cliff failure along the Forkastningsfjellet coastline, Svalbard: Implications for controlling and triggering factors

Based on a morphostructural analysis of a cliff coast segment of Forkastningsfjellet, back analysis of the August 12th, 2016 rock slide situated at 78°19'10"N/15°39'52"E was carried out. This rock slide comprises a volume of 175,000 m<sup>3</sup>, and indicates a partial reactivation at the front of the ~100 million m<sup>3</sup> large postglacial Forkastningsfjellet rock slide. We studied the controlling and triggering factors of the reactivation using a 2-D limit-equilibrium calculations and a 3-D simulation with Scoops3D. Slope instability initiated along a pre-existing listric block fault that was inherited from the postglacial Forkastningsfjellet rock slide. The cause of the failure is attributed to a strength decrease and additional water pressures along the pre-existing sliding plane, possibly in combination with a degradation of the affected weak shales of the Rurikfjellet Formation, which build up a major part of the steep slope.

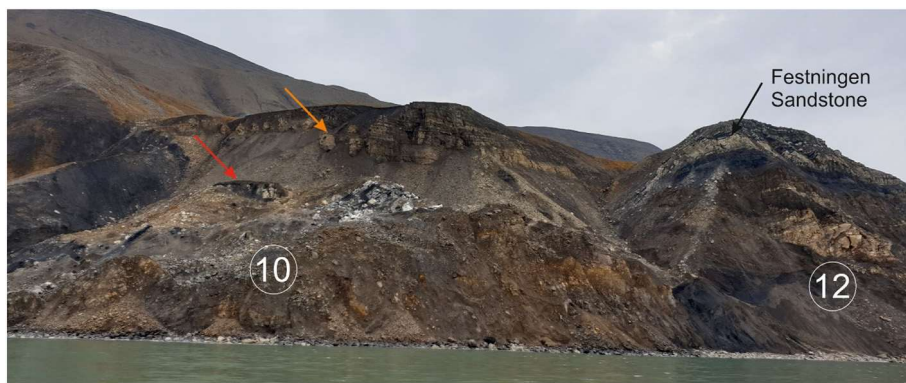
**Fig. 3.** The landslide site, August 30th, 2019, view to the east. The uppermost 30 m of the main scarp is composed of a well-bedded sequence of sandstones and siltstones with closely spaced persistent joints. Slabs of the former land surface are visible on top of the downthrown mass (red arrow). Isolated rock towers ready to topple (orange arrow) and cracks at the landslide crown indicate an active retrogression of the main scarp to the East. Note the rotated sedimentary sequence of Block 12 and the flat-lying beds at the landslide crown of Block 10.

The initial frayed asymmetry of the scarp was smoothed by further minor failures. The detachment of overhanging rock fragments led to further retrogression of the central and NW-part of the crown scarp (Fig. 7C), and a new NE-SW oriented 100 m long rupture surface was created (Fig. 3; Fig. 7C).

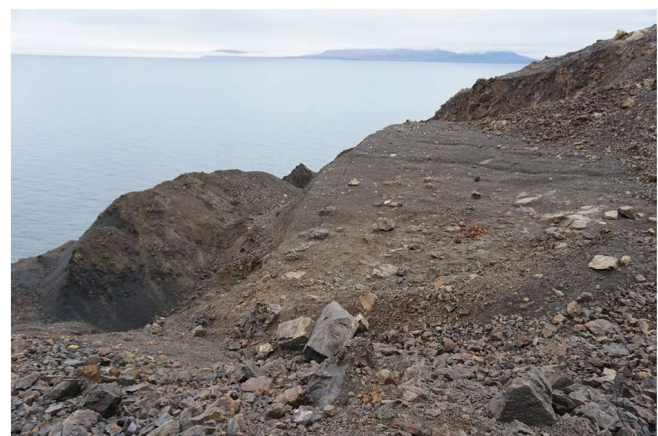
**Fig. 5.** Central part of the rock slide head showing the back rotated blocks to the left and the central block that moved about 40–50 m almost vertically down thereby sustaining the original orientation of the cliff-top drainage rills (view to the North).

In the central part, the head of the displaced rock mass moved about 40–50 m almost vertically down thereby sustaining the original orientation of the cliff-top drainage rills with a backward tilt (Fig. 5).

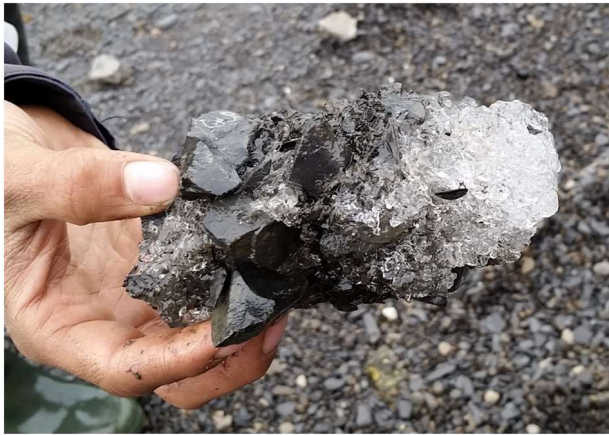
**Fig. 13.** Rock fall fragment with ice-filled cracks from the active upper rock face of the rock slide, indicating weakening of the rock mass by melting of ice-bonded joints.
